Confidential Inspection Report

**12468 Pleasant Drive
Olathe, KS 66062**

Report: Sample 09w10109-2000-2999 sq ft
Inspection Address: 12468 Pleasant Drive, Olathe, KS 66062

Page 3
Date: January 9, 2009

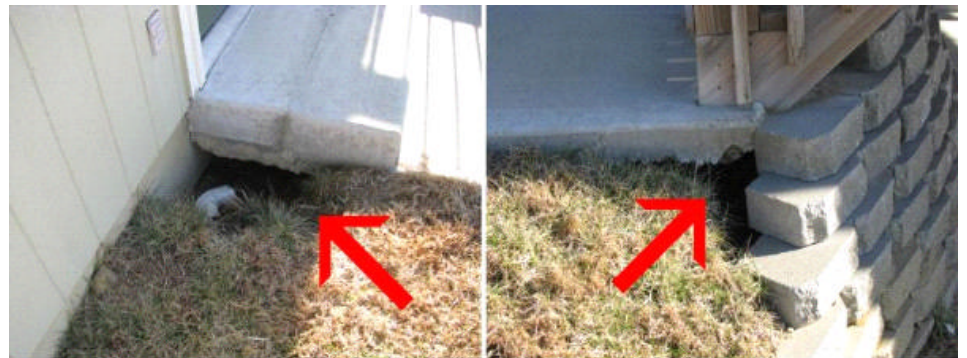
Dirt has eroded or been removed from under the upper level patio slab. Recommend replacing compacted dirt under and at the sides of the slab to prevent further erosion and settlement.

Dirt has eroded or been removed from under the upper level patio slab. Recommend replacing compacted dirt under and at the sides of the slab to prevent further erosion and settlement.

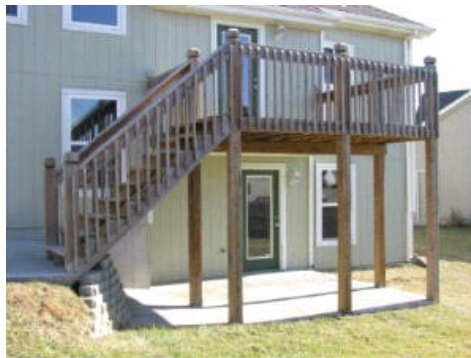
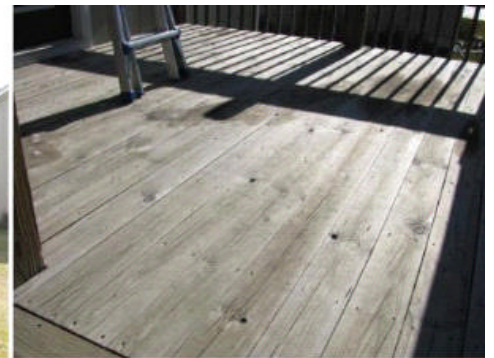
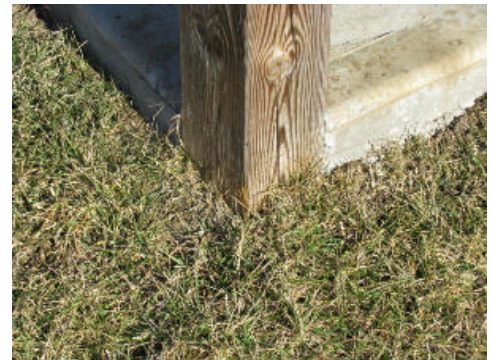
Material : Treated wood.
Condition: Posts are set in concrete, however, soil has settled around them. Contact with soil encourages wood rot. Correction is recommended. Recommend sealing the deck routinely to prevent rotting from weather.

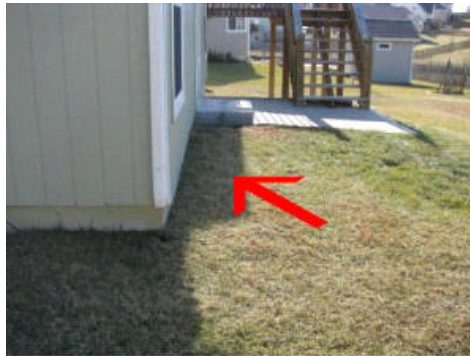
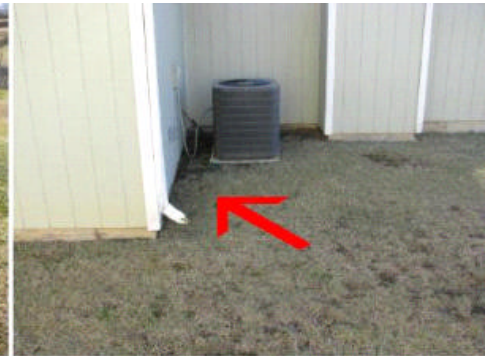
At North side, At West side. Recommend adding compacted dirt and / or re-grading to create a positive slope away from the foundation. Do not obscure the foundation or bring the soil into contact with the siding.

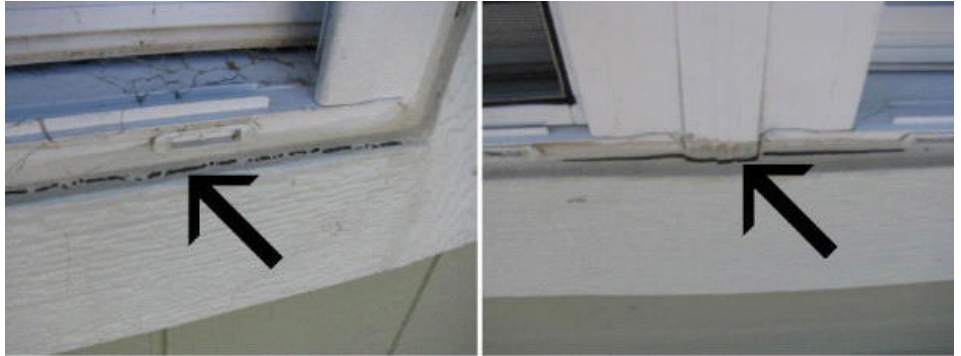
Caulking and sealing is necessary wherever weather can penetrate joints, cracks or other small openings. It is important to maintain caulking.

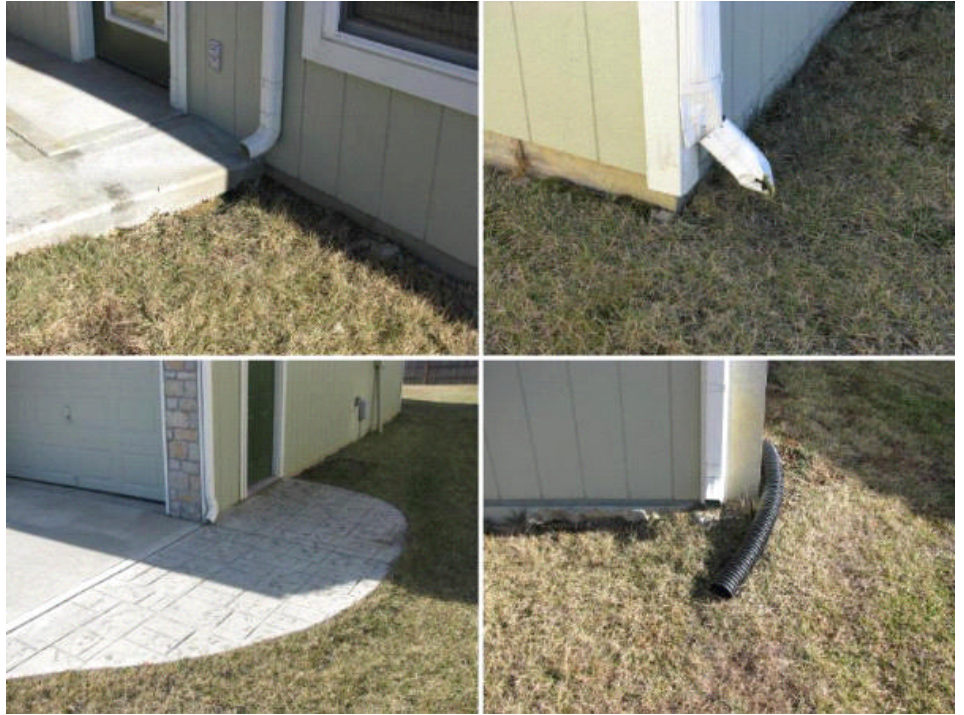
Downspout extensions are in need of repair / correction to direct water away from foundation at: North, South, West.

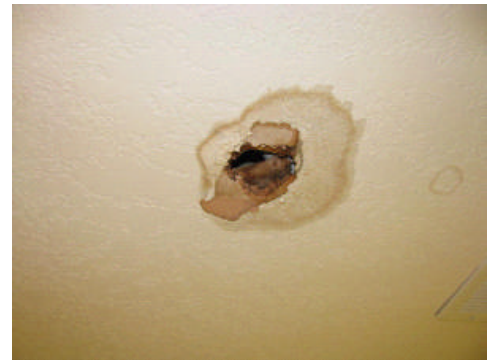
Ceiling Damage noted, appears to be caused by the master bathroom shower drain. Recommend repairing the ceiling after the shower drain has been repaired.

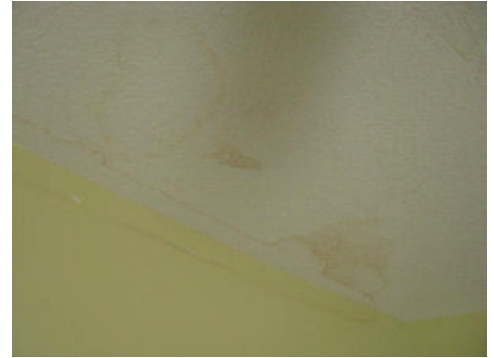
Drywall, Satisfactory except as noted. Stains were noted at the ceiling of the basement bedroom, appears to be caused by a prior leak.

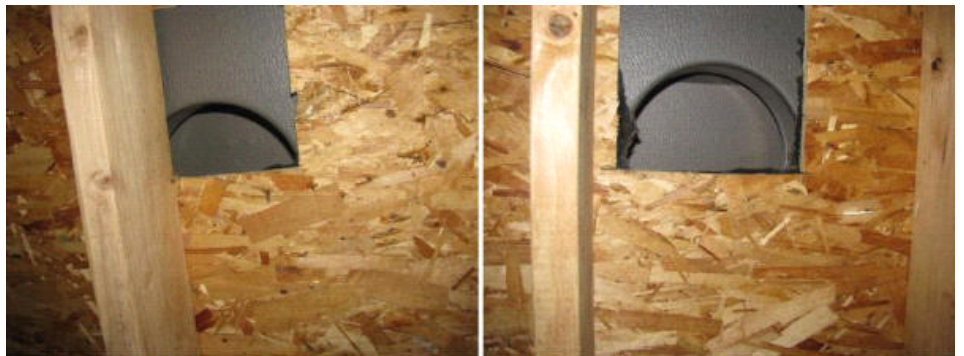
Ventilation openings in the attic blocked or partially blocked. The sheathing cutout for the roof vents should be cut to full size.

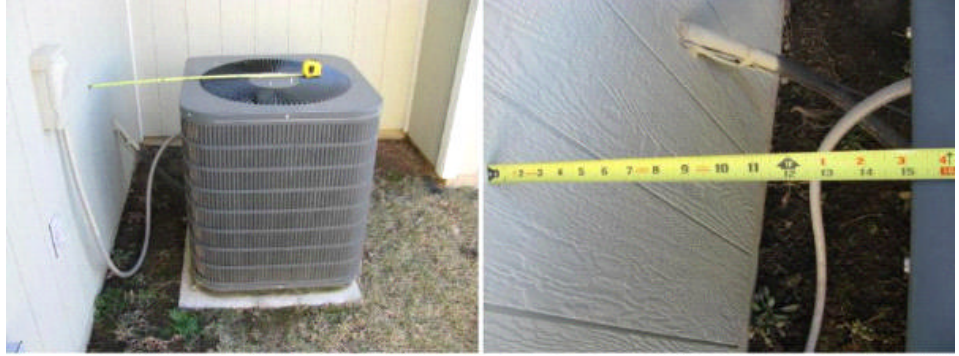
Condenser unit is located outside. Outside air temperature has been too cold to operate the compressor without the risk of damage. Free air flow to the condenser is blocked. Provide 2 ft. of free air space at sides of the unit.
